Debris/Ice/TPS Assessment and Integrated Photographic Analysis of Shuttle Mission STS-82

Technical Memorandum 112647

April 1997

11 February 1997

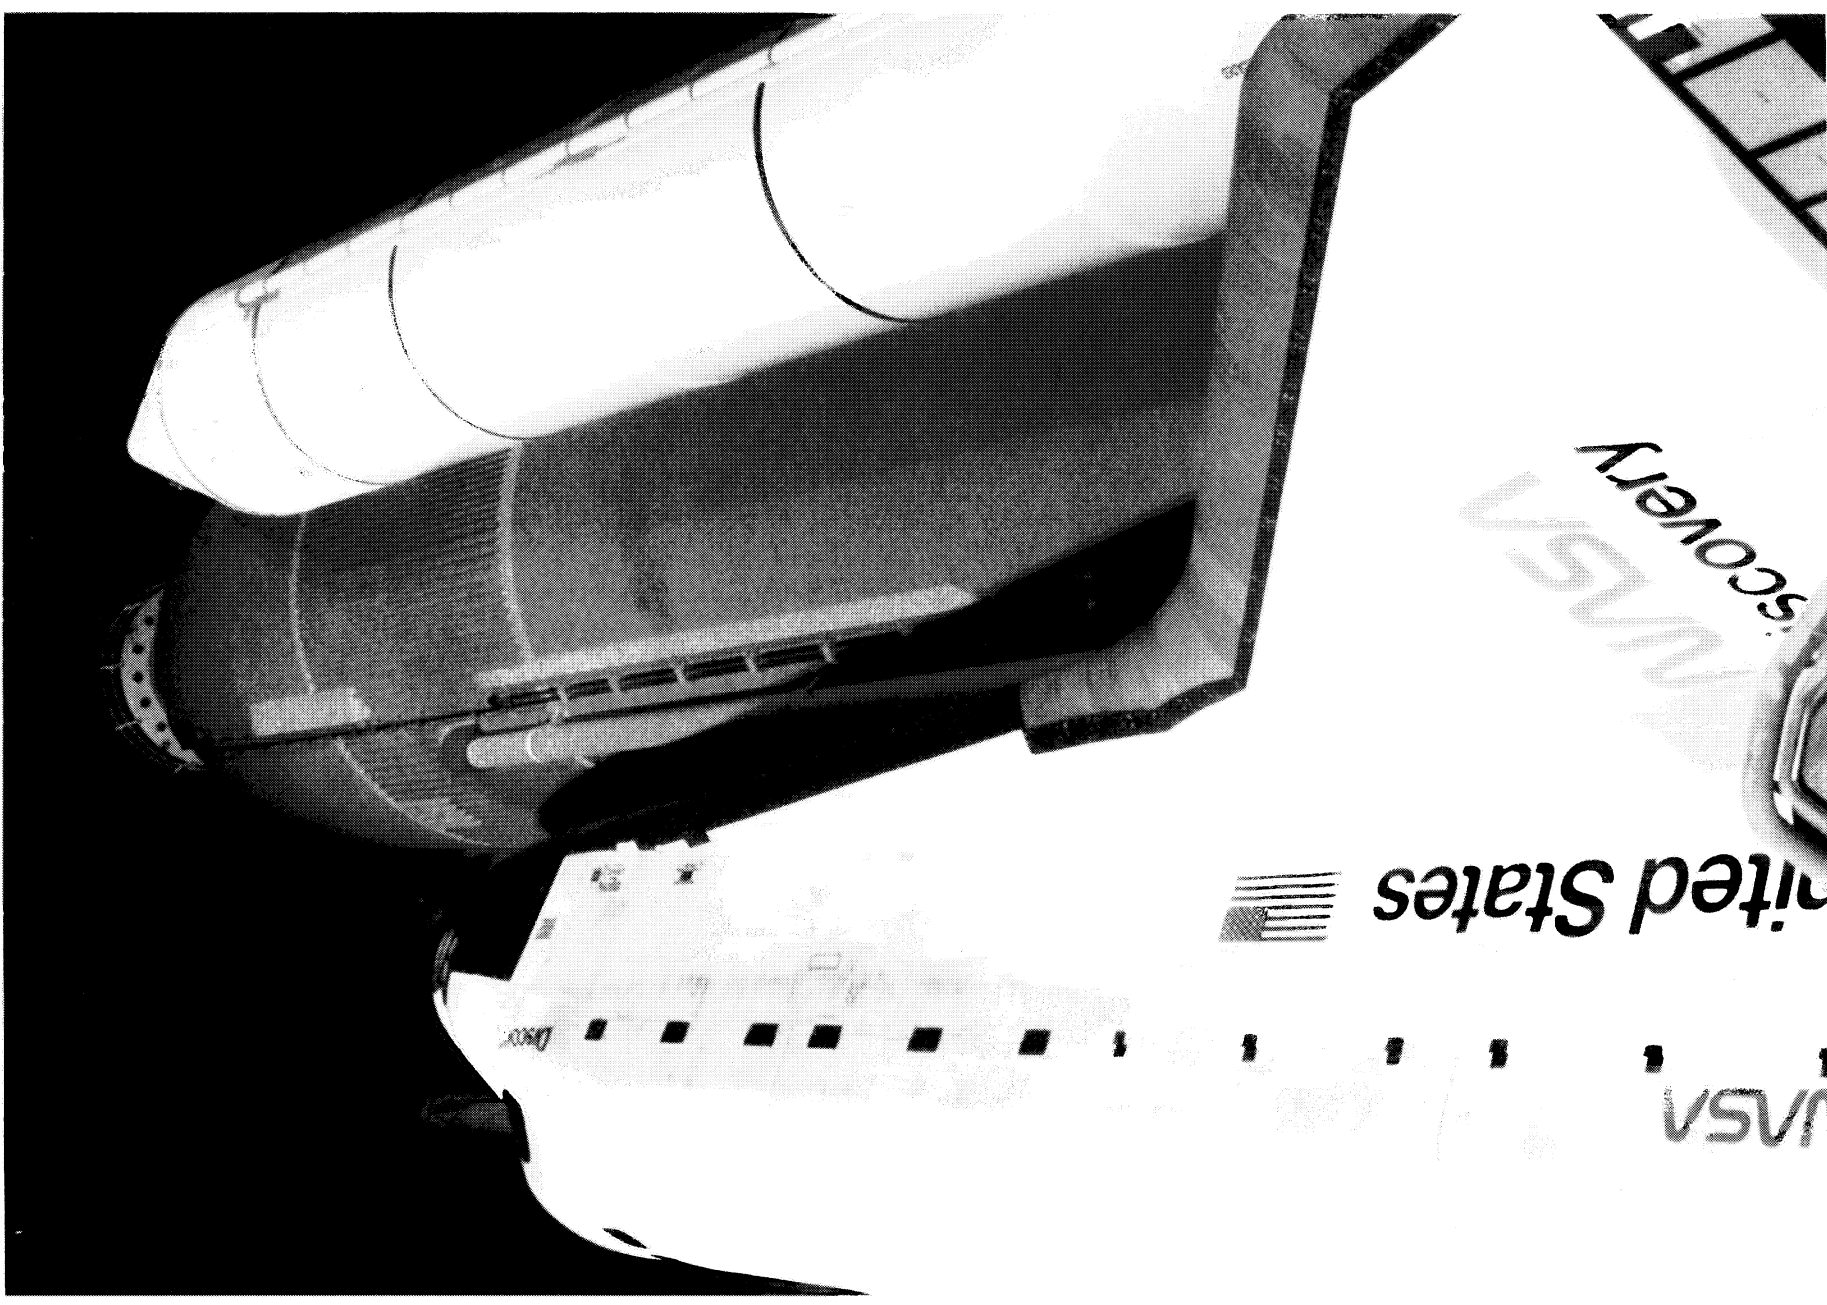
Photo 3: STS-82 Cryoload for Flight

OV-103 Discovery (22nd flight), ET-81 (LWT 74), BI-085 SRB's

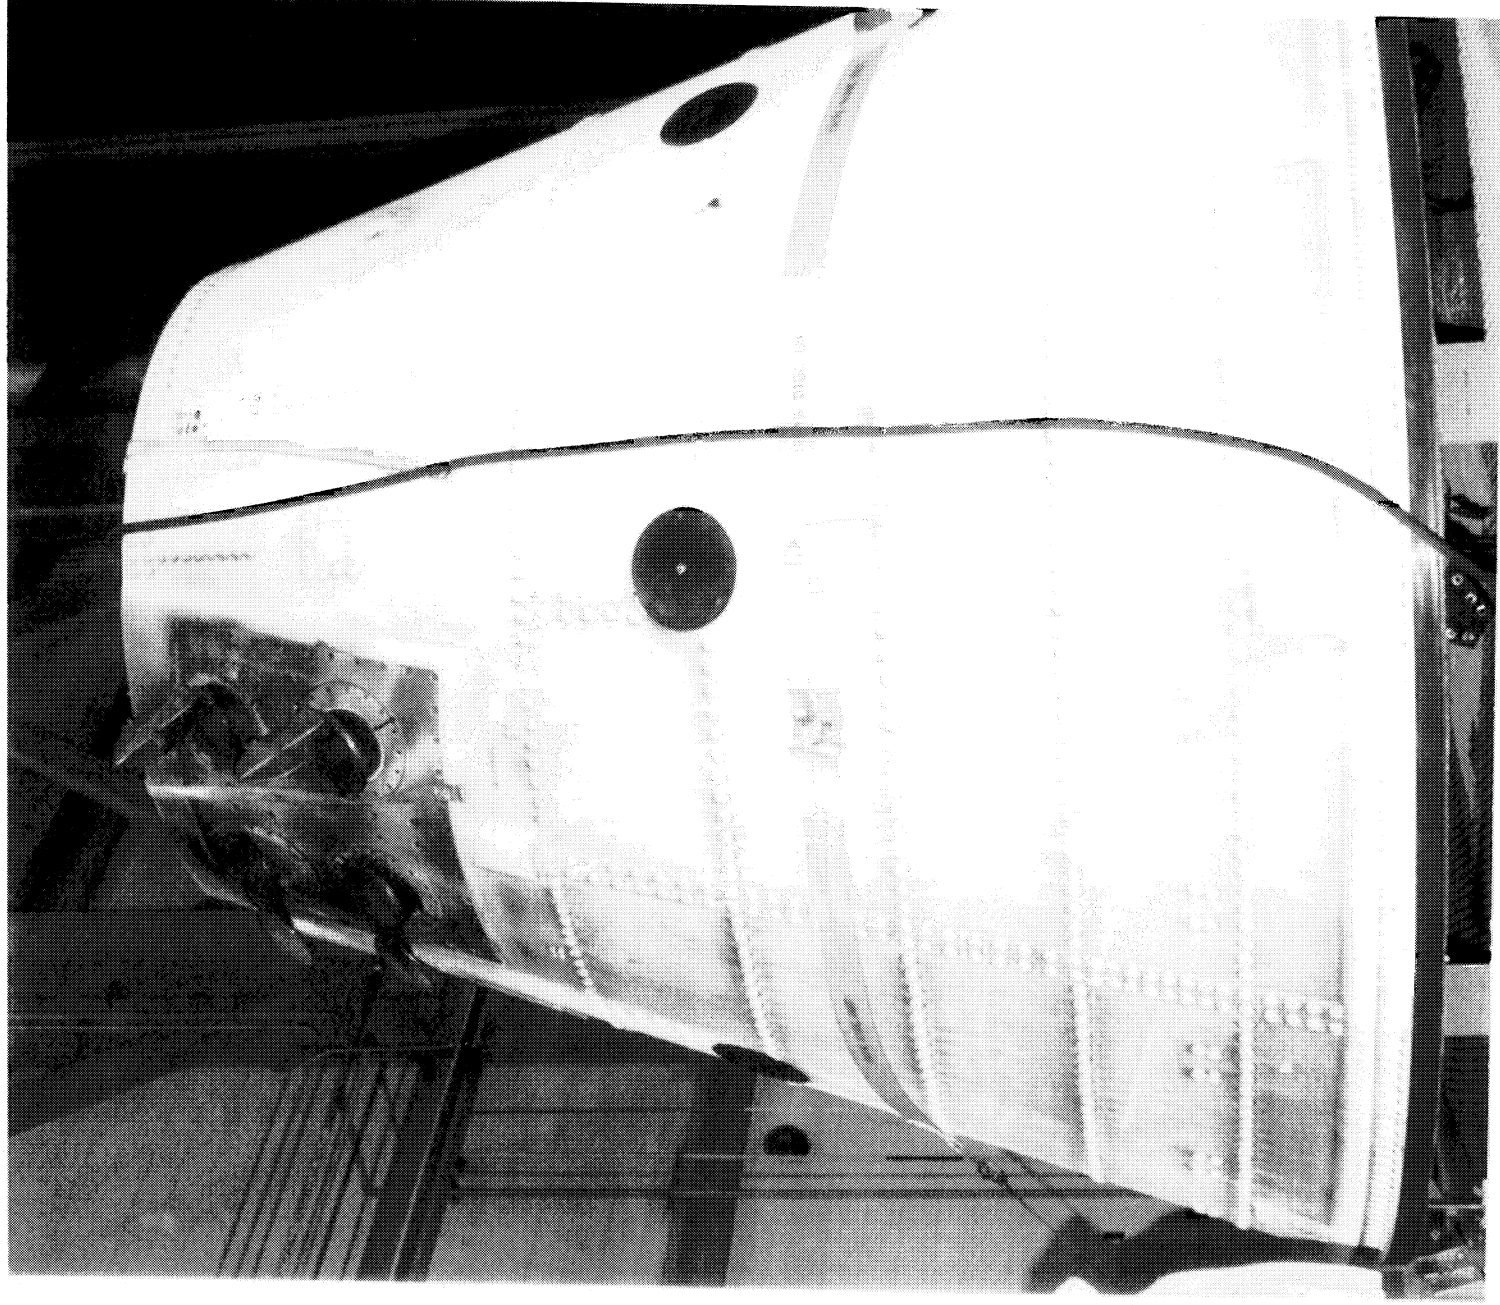
Photo 10: LH Frustum

The Solid Rocket Boosters were inspected at Hanger AF after retrieval. Both frustums were in excellent condition. No MSA-2 debonds over acreage or fasteners were detected. All eight BSM aero heat shield covers had locked in the fully opened position, though the two outboard cover attach rings on the left frustum had been bent by parachute riser entanglement. There were no clear indications of aft skirt stud hole breaching or stud hang-ups on this flight (review of launch films support this finding). The holddown post Debris Containment Systems (DCS) plungers were seated and appeared to have functioned normally with the exception of HDP#4, where the plunger seating was obstructed by the frangible nut halves. This condition may have been the result of splashdown. Tape inadvertently left on the LH SRB aft booster just aft of the IEA during pre-launch processing was mostly intact.

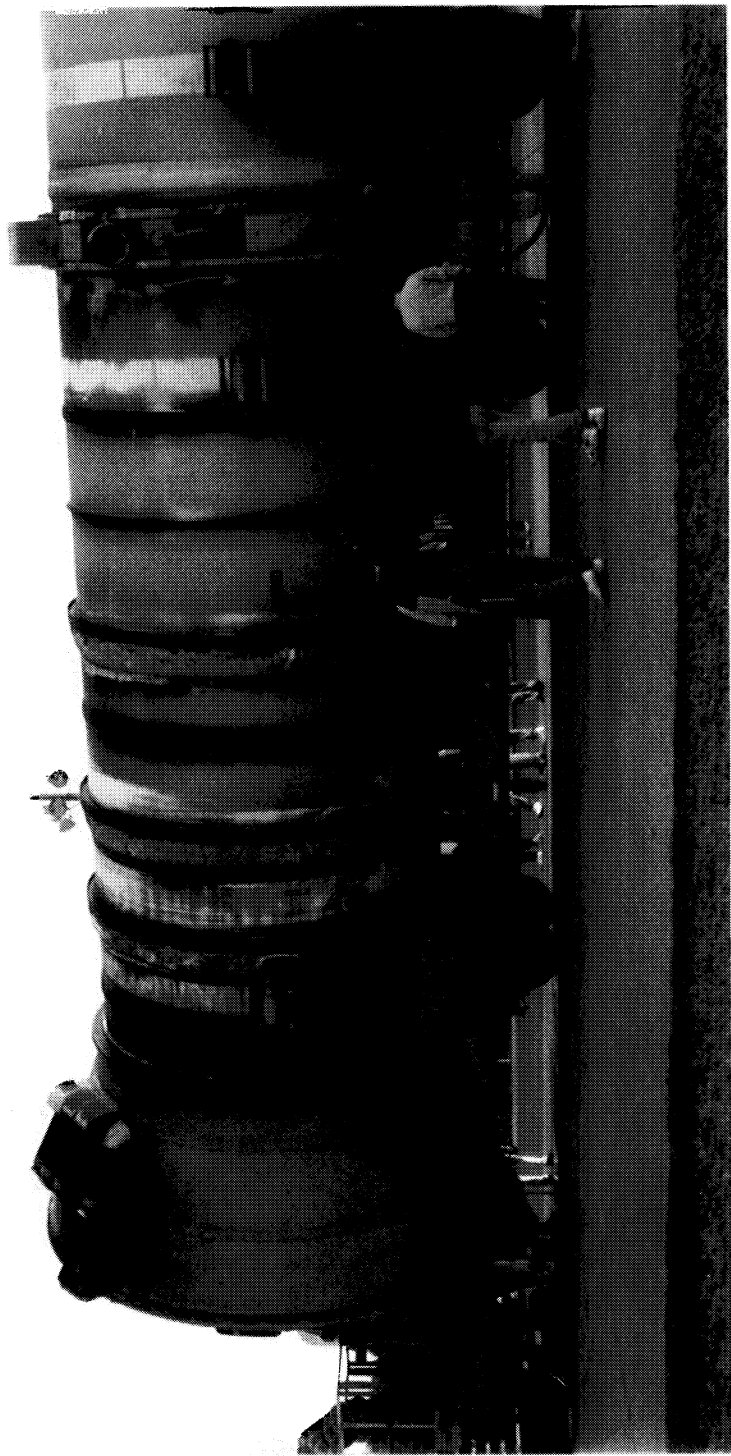
Photo 14: LH Aft Booster

Tape was inadvertently left on the LH SRB aft booster just aft of the IEA. The tape, used during IEA closeout/ablator trimming, was detected during the Pre-Launch Inspection, but after the Orbiter Weather Protection (OWP) platforms had been retracted. MRB approval (IPR 82V-0262) to fly the tape rather than re-extending the OWP's was obtained.

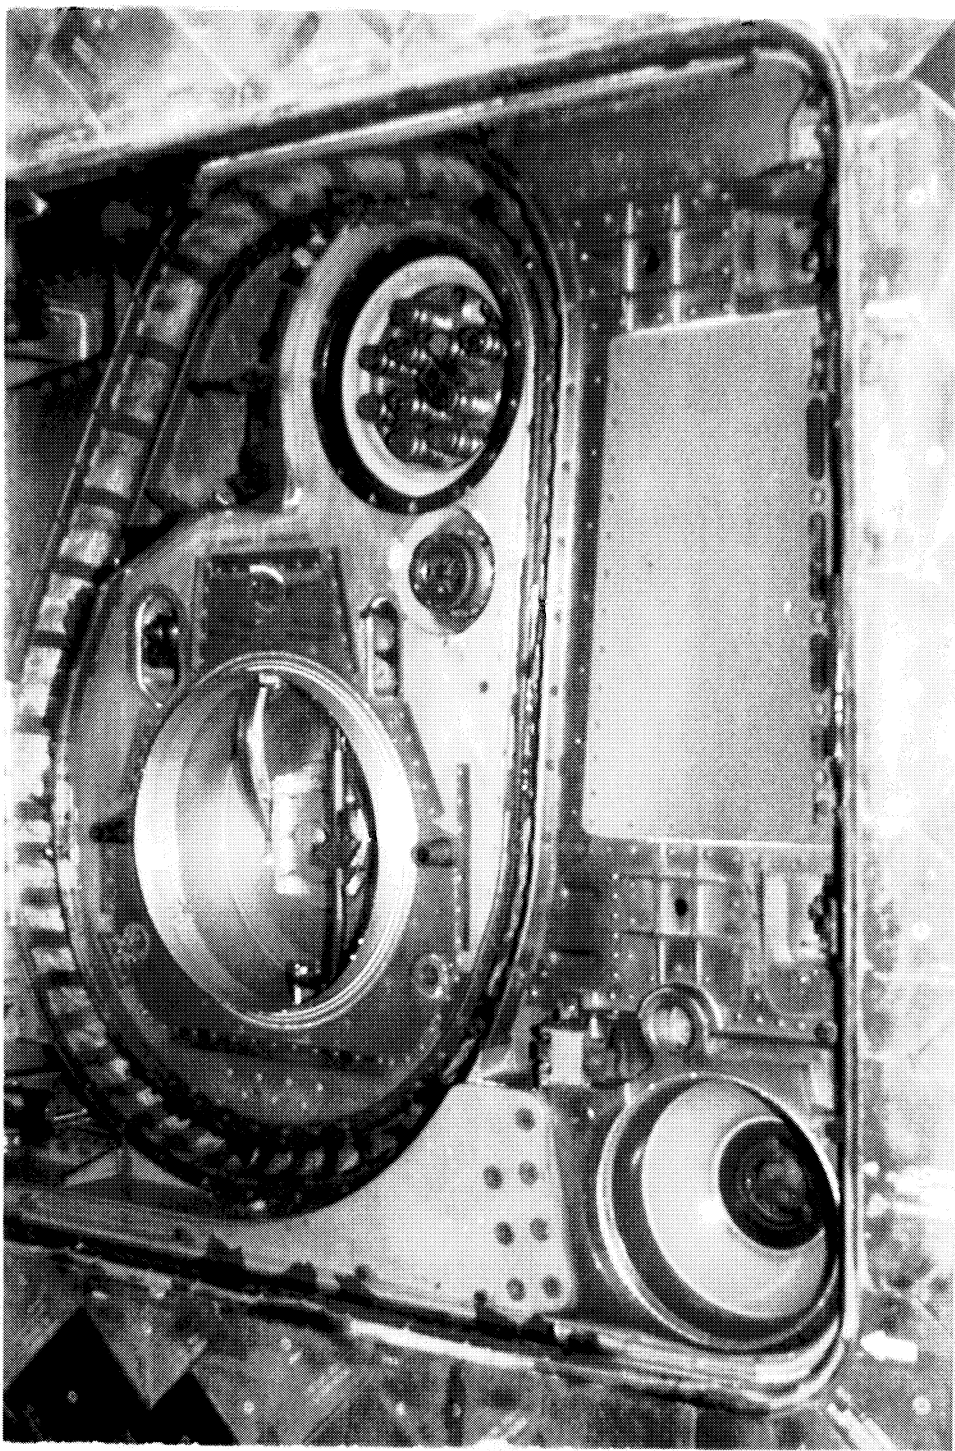
Photo 20: LO2 Umbilical

ET/Orbiter separation devices EO-1, EO-2, and EO-3 functioned normally. No ordnance fragments were found on the runway beneath the umbilical cavities with the exception of a 2-inch long piece of white RTV. Bent metal, approximately 1-inch in length by 1/4-inch wide, was visible on the trailing edge of a spacer between two bolt heads on the inside surface of the LO2 ET door near the forward outboard corner.

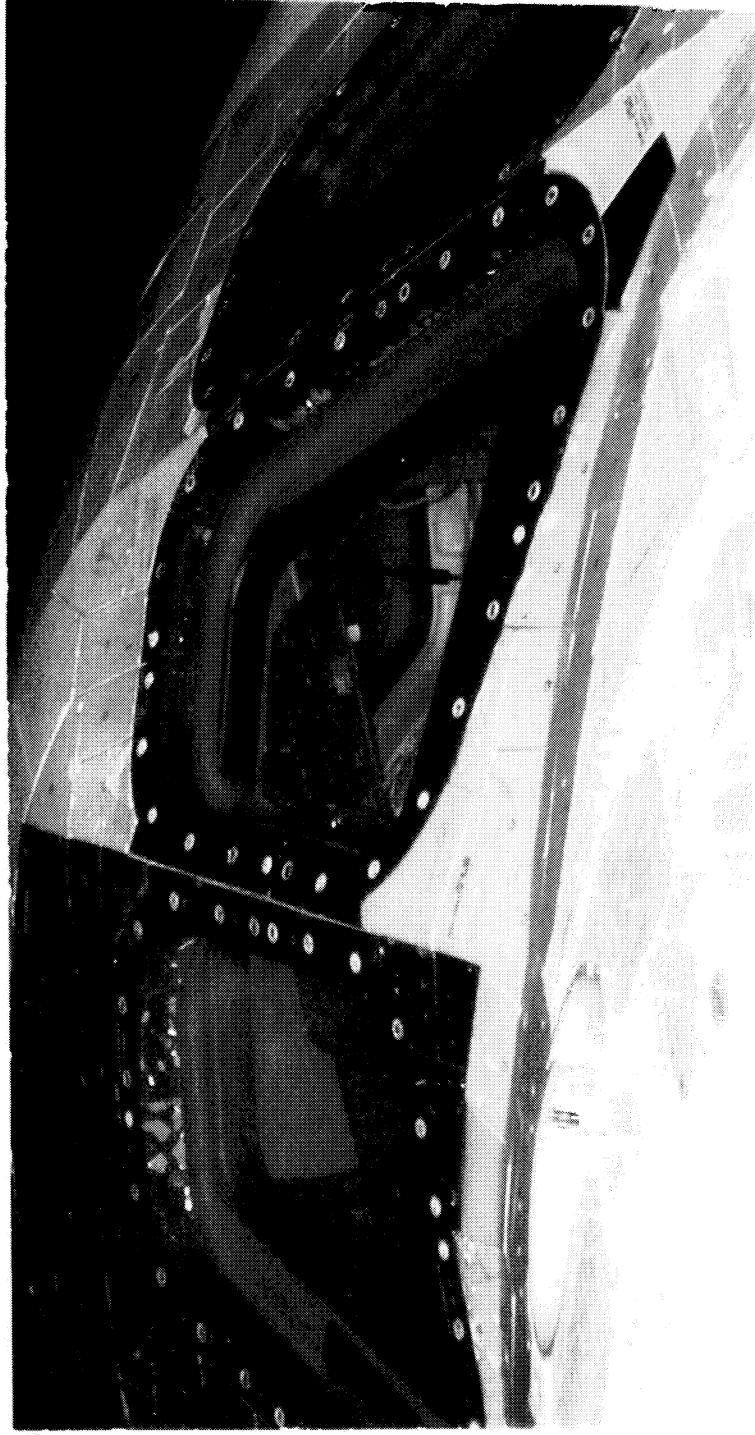
Photo 22: Orbiter Windows 1 - 3

Hazing and streaking of forward-facing Orbiter windows was typical. Damage sites on the window perimeter tiles appeared to be average in size and number. A somewhat unusual finding consisted of a cluster of 14 hits, including four larger than 1-inch, in the black-tiled area between windows #3 and #4. These damage sites are believed to be the result of impacts from FRCs thruster paper covers/RTV adhesive.

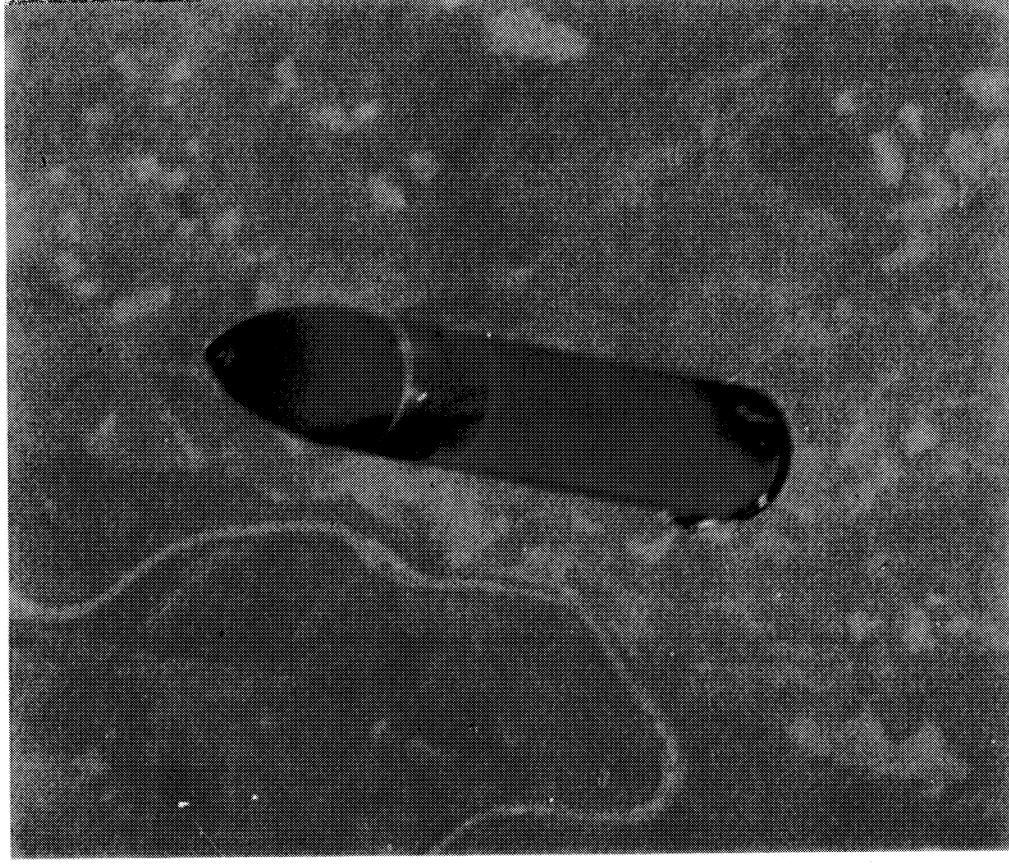
Figure 2.5.1 (A) Handheld Camera View of the External Tank

DTO-312 (method 4) handheld photography of the STS-81 external tank after separation was acquired with a Nikon 35 mm camera with a 400 mm lens and a 2X extender. The OMS-2 attitude pitch maneuver was performed early to assist the crew members in acquiring the ET visually.

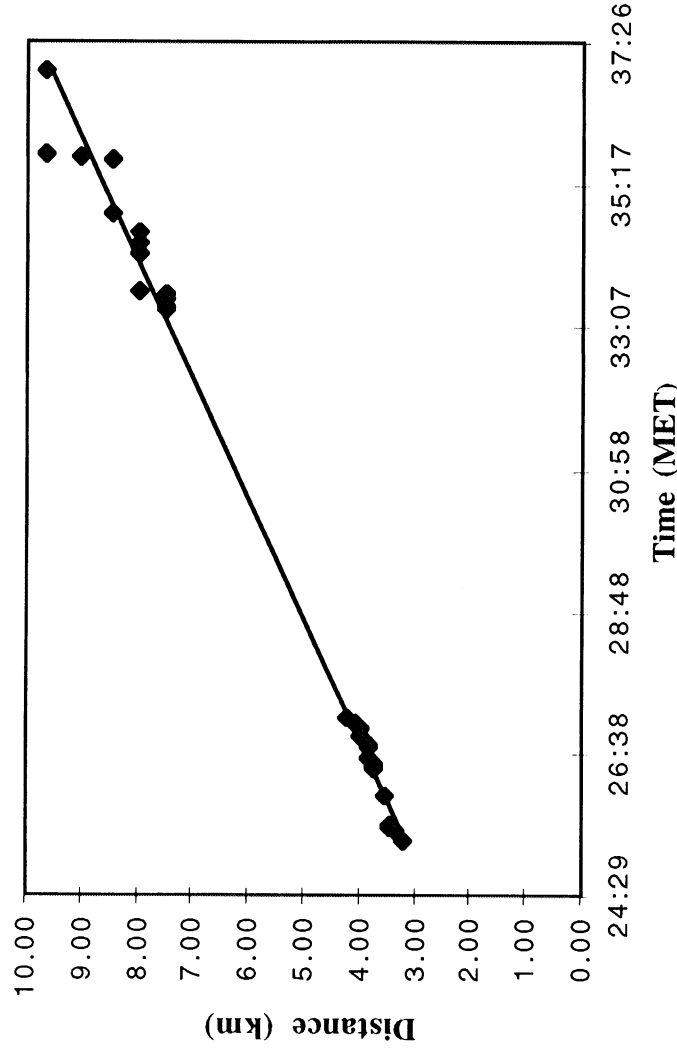
Figure 2.5.1 (B) ET Separation Velocity

The distance of the external tank was calculated on twenty-nine frames. On the first view, the external tank was calculated to be a distance of 3.2 km away from the Orbiter at 25:17 MET. On the last view, the tank was calculated to be at a distance of 9.7 km (11.3 minutes after the first view or 36.6 MET). The tank separation average velocity was determined to be 9 m/s with an uncertainty of approximately 1 m/s. The separation velocity was larger than previous mission measurements since the pictures were taken at a later time. The tank tumble rate was approximately 1.6 deg/sec and the roll rate was too small to be measured.

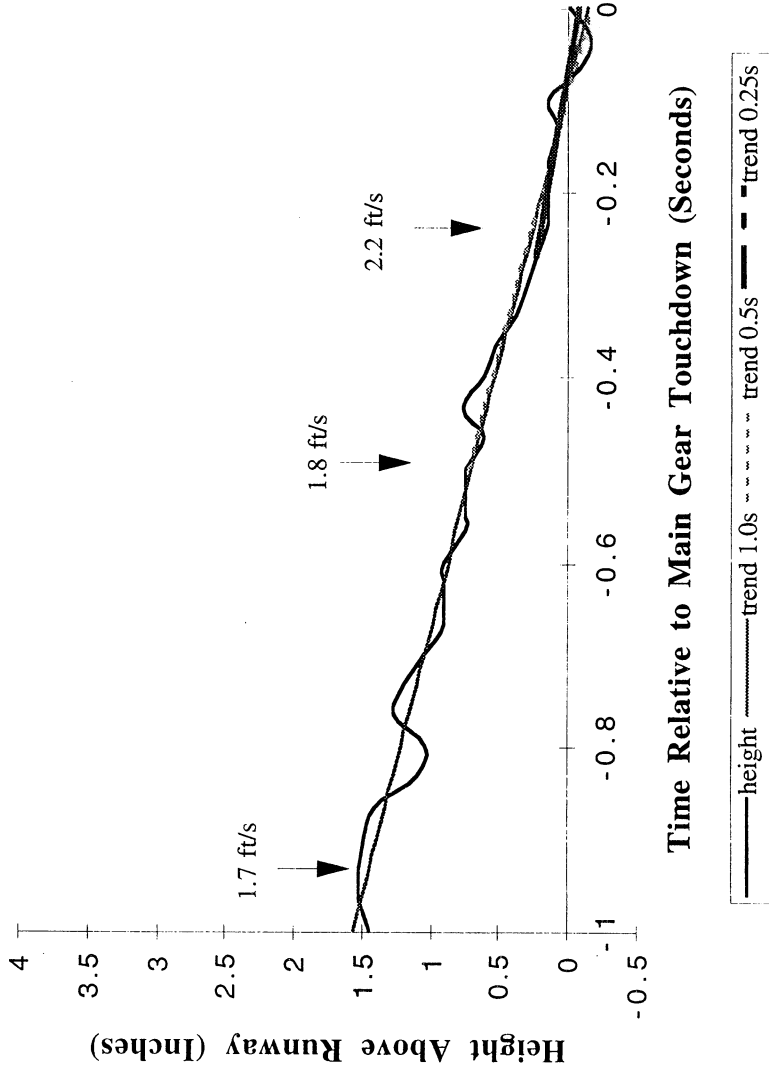
Figure 2.6.1 (A) Main Gear Height Versus Time Prior To Touchdown (Video)

The measured main gear sink rate values were found to be below the maximum allowable values of 9.6 ft/sec for a 211,000 lb. vehicle and 6.0 ft/sec for a 240,000 lb. vehicle (the landing weight of the STS-82 Orbiter was reported to be 213,710 lb.). The sink rate measurements for STS-82 are given in Table 2.6.1. In Figure 2.6.1(A), and 2.6.1(B), the trend of the measured data points for the image data is illustrated.
